Installation instructions

For set # 3.1109

1982-92 Camaro-Firebird
Secondary crossmember mounts

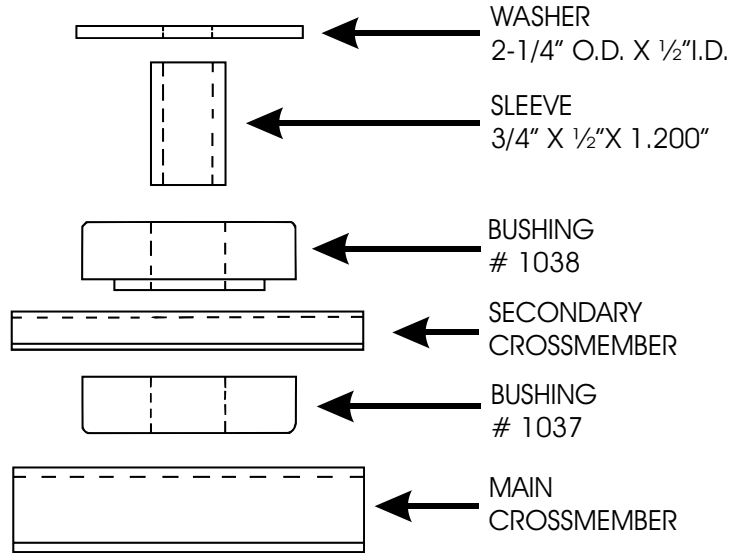
Before reassembling x-member.
Check for cracks at main
transmount mounting area. IF
cracked, it mst be replaced or
repaired. Recommended for use
with polyurethane main transmission
mount. Part #3-1108

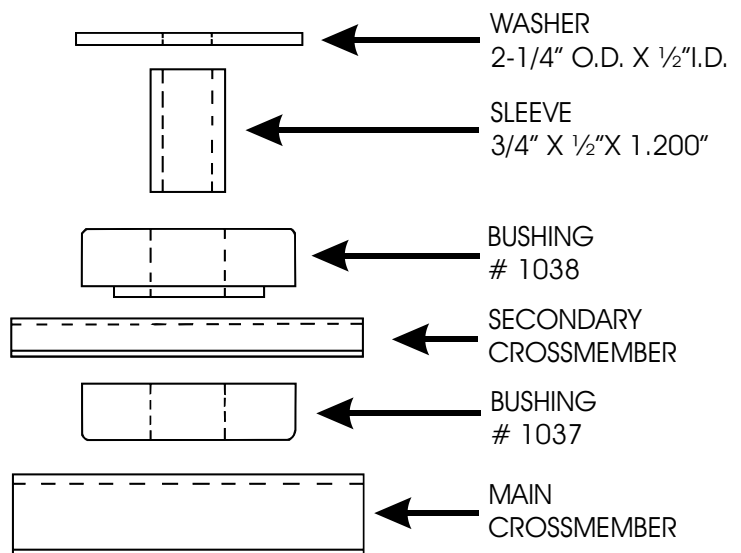
Before reassembling x-member.
Check for cracks at main
transmount mounting area. IF
cracked, it mst be replaced or
repaired. Recommended for use
with polyurethane main transmission
mount. Part #3-1108
